Tier 1 Evaluation of Pollutant Sources to the Impounded Reach of Clifton 2 Mill Dam, Pacolet River, Spartanburg County, South Carolina

October 2012

**U.S. Department of the Interior
Fish and Wildlife Service**

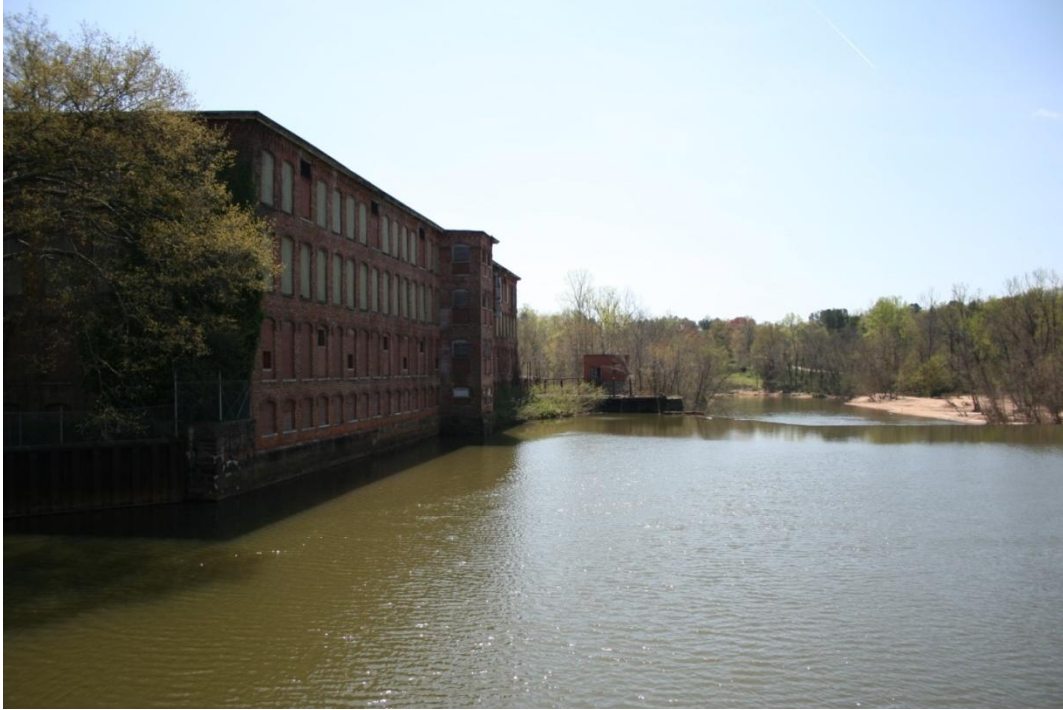
Figure 1. Clifton 2 Mill and impoundment, Pacolet River, SC. Photo facing downstream from SR 59 (Clifton Glendale Road) (photo from SC DHEC)

The Clifton 2 Mill Dam (34°58'45"N, 81°48'56"W) (Figures 1 through 3) is a chevron-shaped stone dam about 375-feet long and about eight to 10-feet tall. Built in the 1880s, the dam has created a small impoundment on the Pacolet River, which is about 250 to 300 feet wide upstream of the dam (the river is about 100 to 200 feet wide downstream of the dam). The extent of impoundment is less than one river mile as the Clifton 1 Mill Dam is 0.9 river miles upstream of the Clifton 2 Mill Dam. The Converse Dam is two miles upstream of the Clifton 2 Mill Dam.

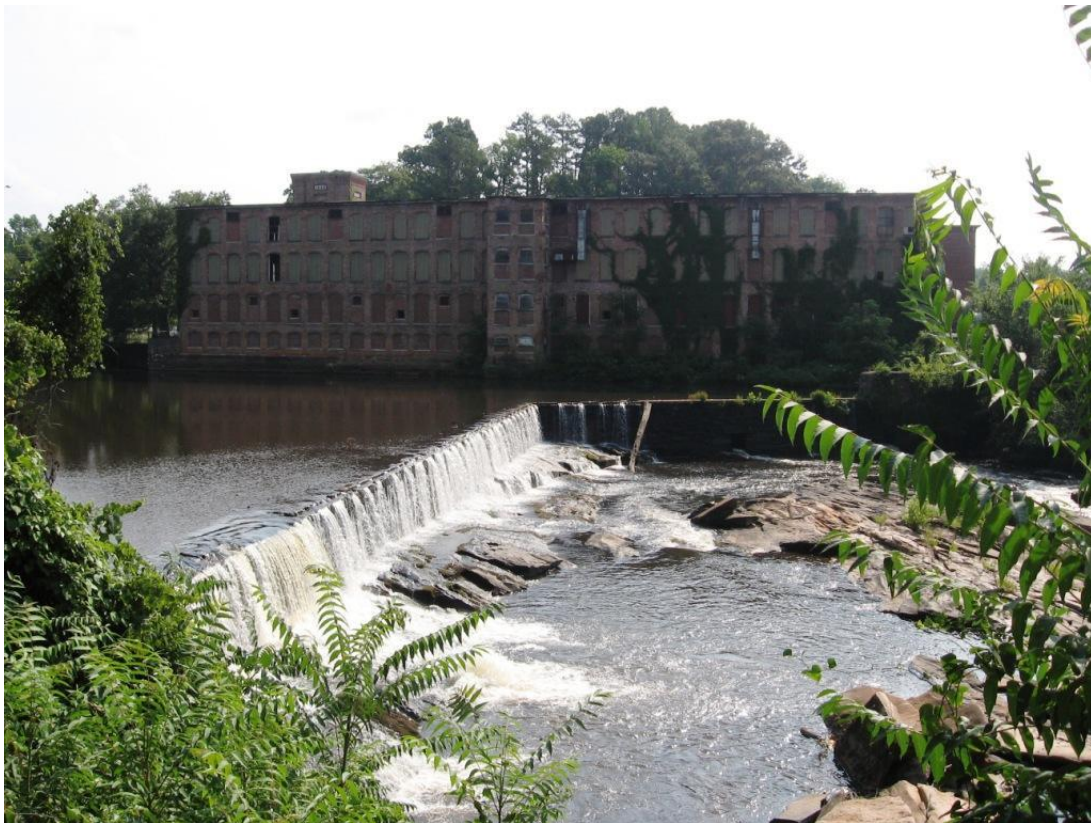
Figure 2. Clifton 2 Mill and impoundment, Pacolet River, SC. Photo facing east from Goldmine Road (SR 108) (July 14, 2011 photo from Lynnette Batt, American Rivers)

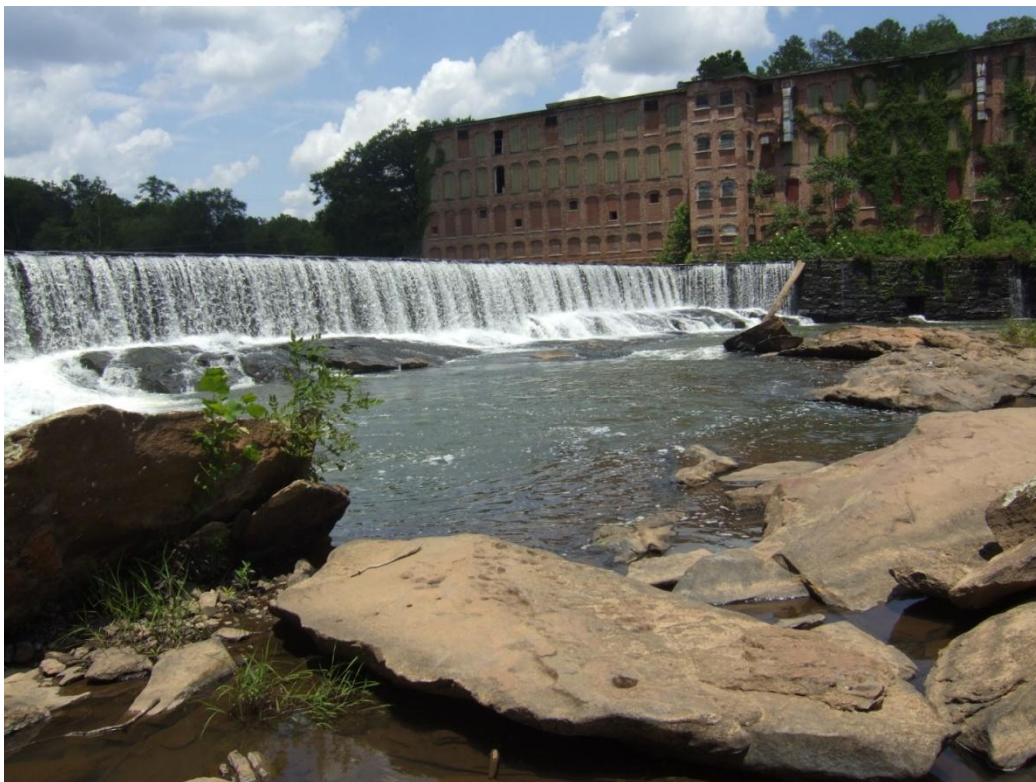
Figure 3. Clifton 2 Mill and dam, Pacolet River, SC. Photo facing upstream from right bank (June 7, 2012 photo from Tom Augspurger, USFWS).

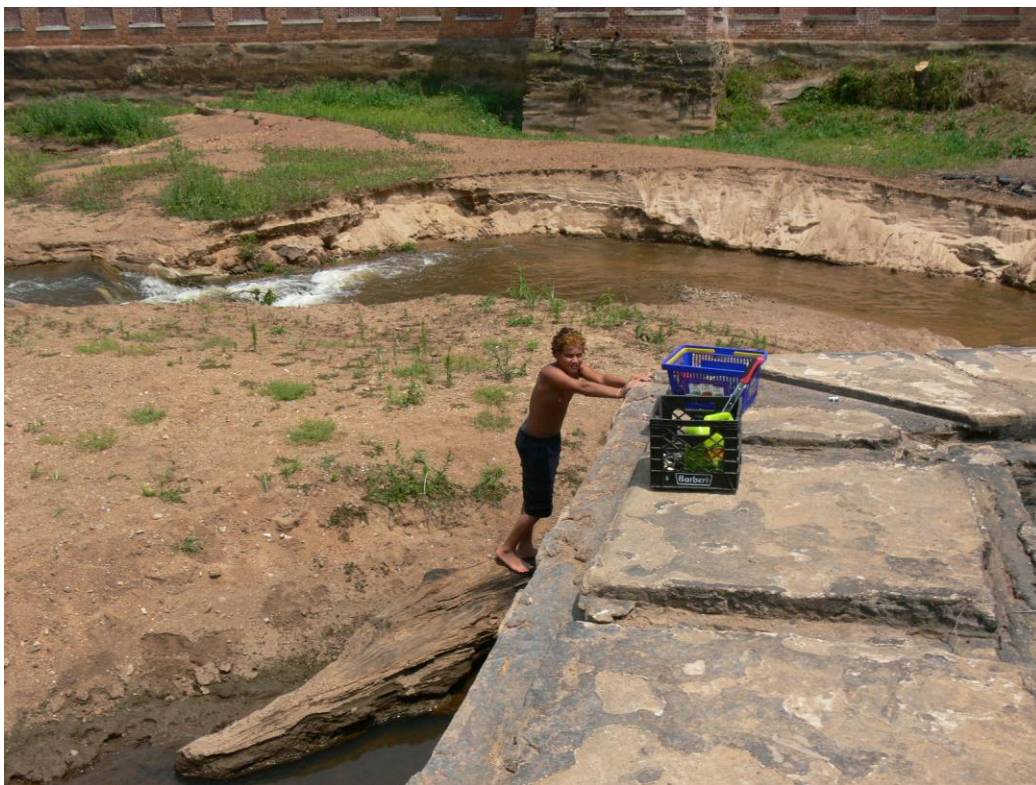
Figure 4. Clifton 2 Mill Dam, Pacolet River, SC, during gate replacement and dewatering (August 3, 2007 photo provided by Scott MacDonald).

The Clifton 2 Mill is parallel to the Pacolet River with its west exterior wall forming the eastern (left) bank of river. The dam's tailrace is located on the left side of the dam and runs north to south for about 870 feet before rejoining the Pacolet River. The mill buildings are in the process of demolition for brick and lumber salvage. The dam is no longer used for the mill, but it is intact. In 2007, the gates deteriorated and the impoundment was dewatered (Figures 4 through 6) over a period of about two years until gates were replaced (Scott MacDonald and George Fields, pers. comm.). From these figures and aerial images during this period (Figures 7 and 8), it is apparent that the river bottom near the dam is comprised predominantly of sand, consolidated enough to walk-on when dry, and that much substrate was scoured from the impounded reach during the period when the gates were open.

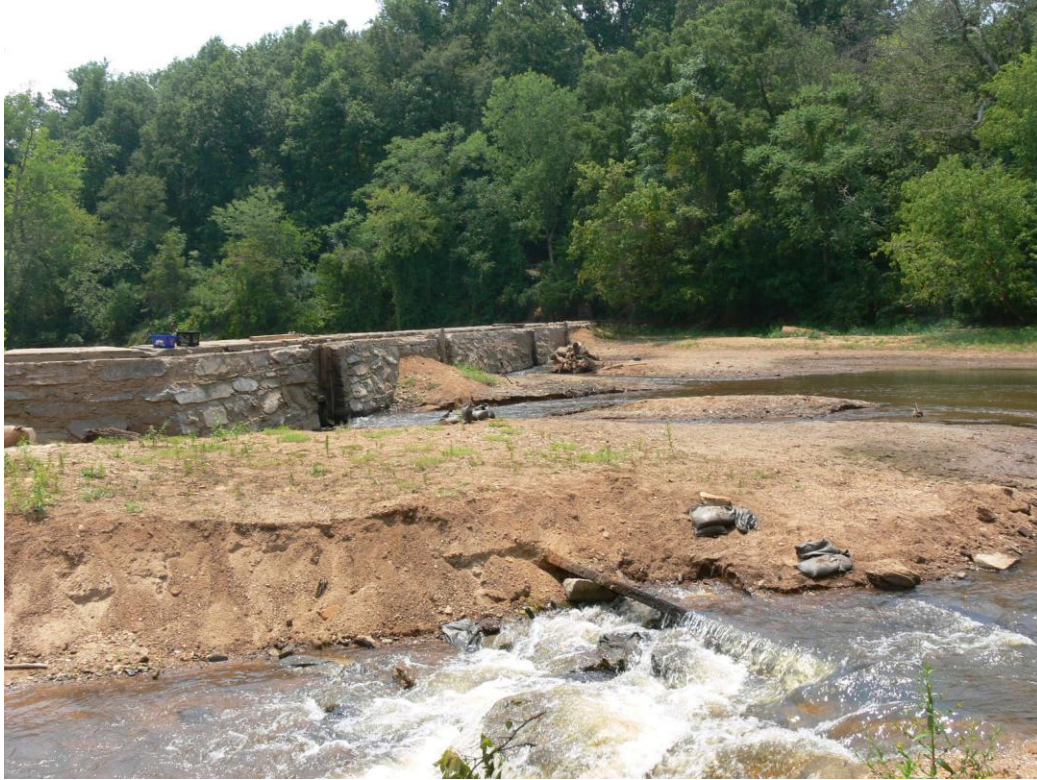
Figure 5. Clifton 2 Mill Dam, Pacolet River, SC, during gate replacement and dewatering (August 3, 2007 photo provided by Scott MacDonald).

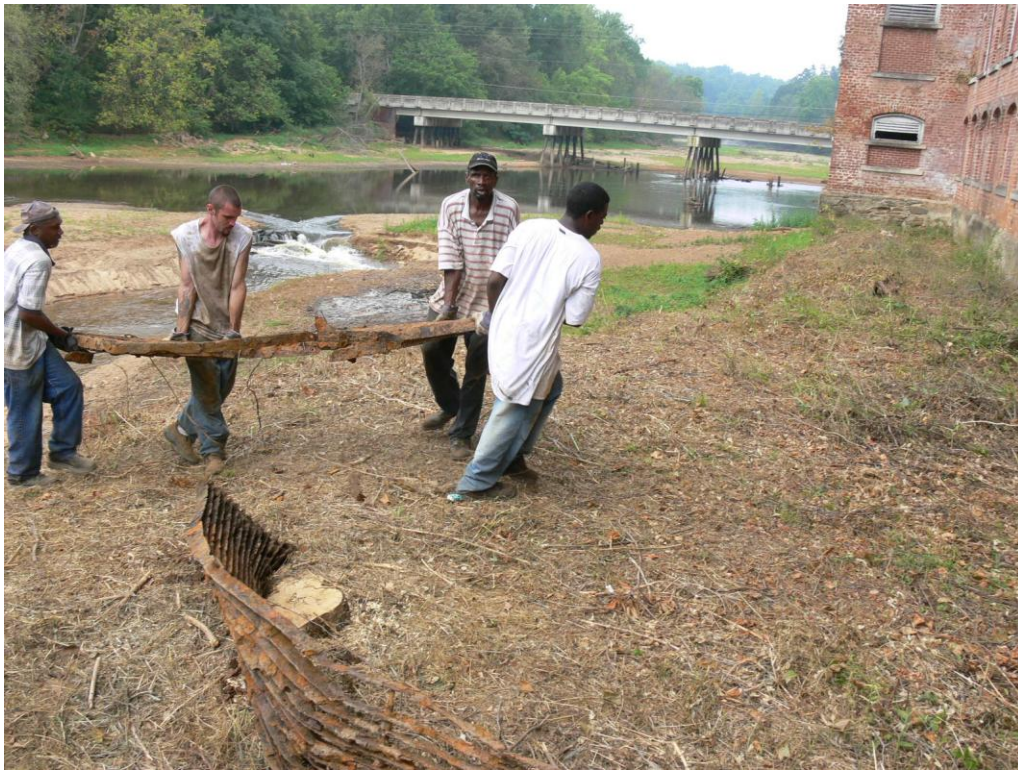
Figure 6. Clifton 2 Mill Dam, Pacolet River, SC, during gate replacement and dewatering (July 30, 2007 photo provided by Scott MacDonald).

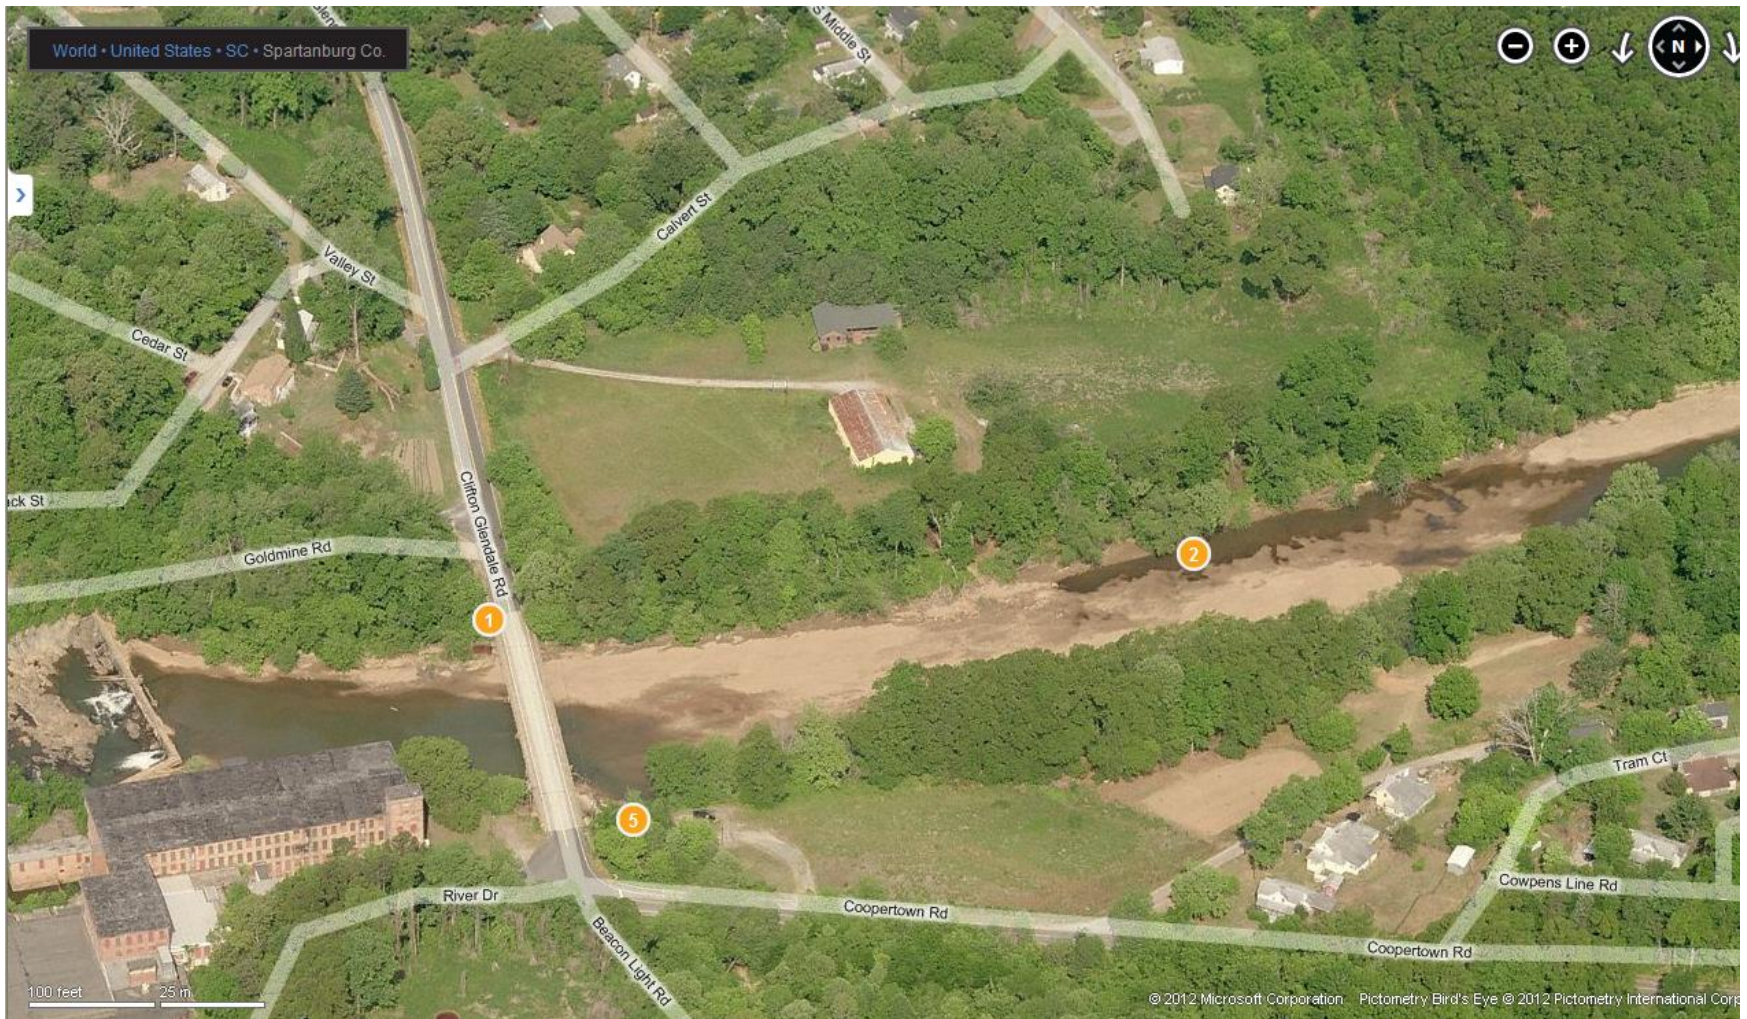
Figure 7. Pacolet River at Clifton 2 Dam during 2007 gate replacement and dewatering (image from Bing Maps).

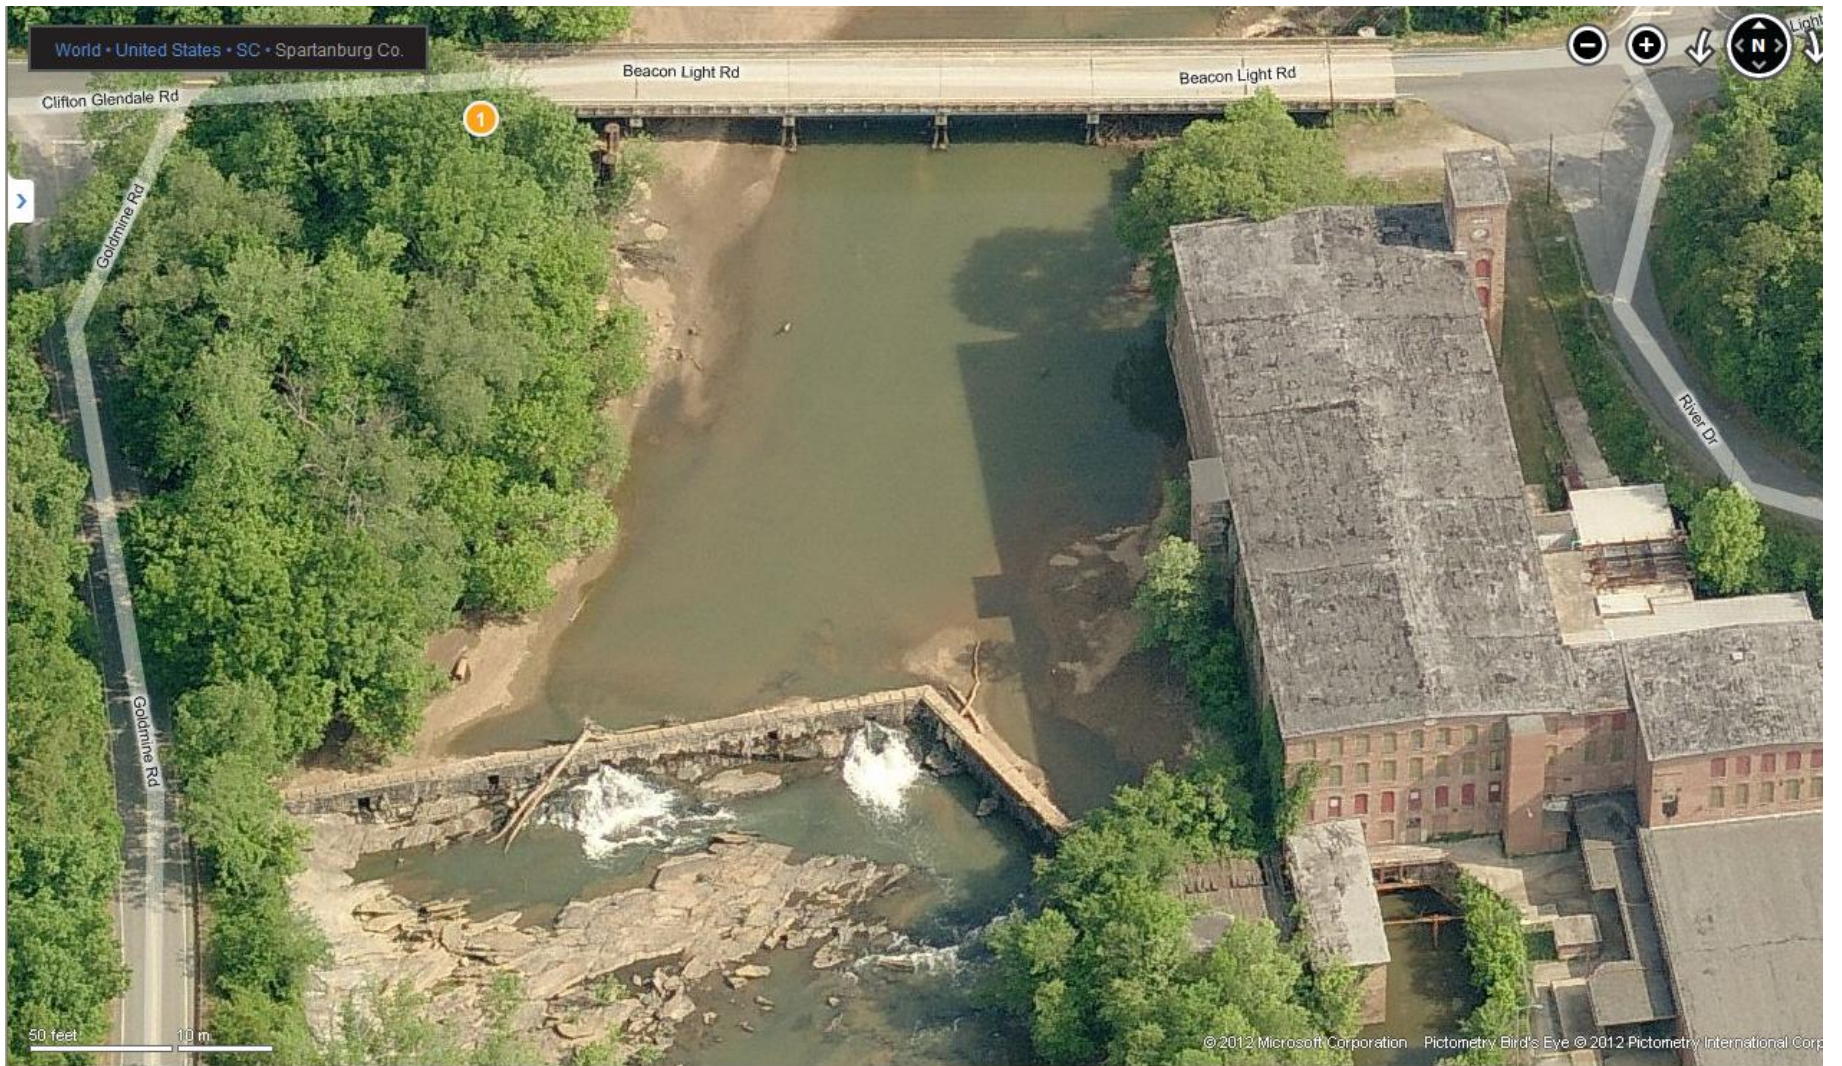
Figure 8. Pacolet River at Clifton 2 Dam during 2007 gate replacement and dewatering (image from Bing Maps).

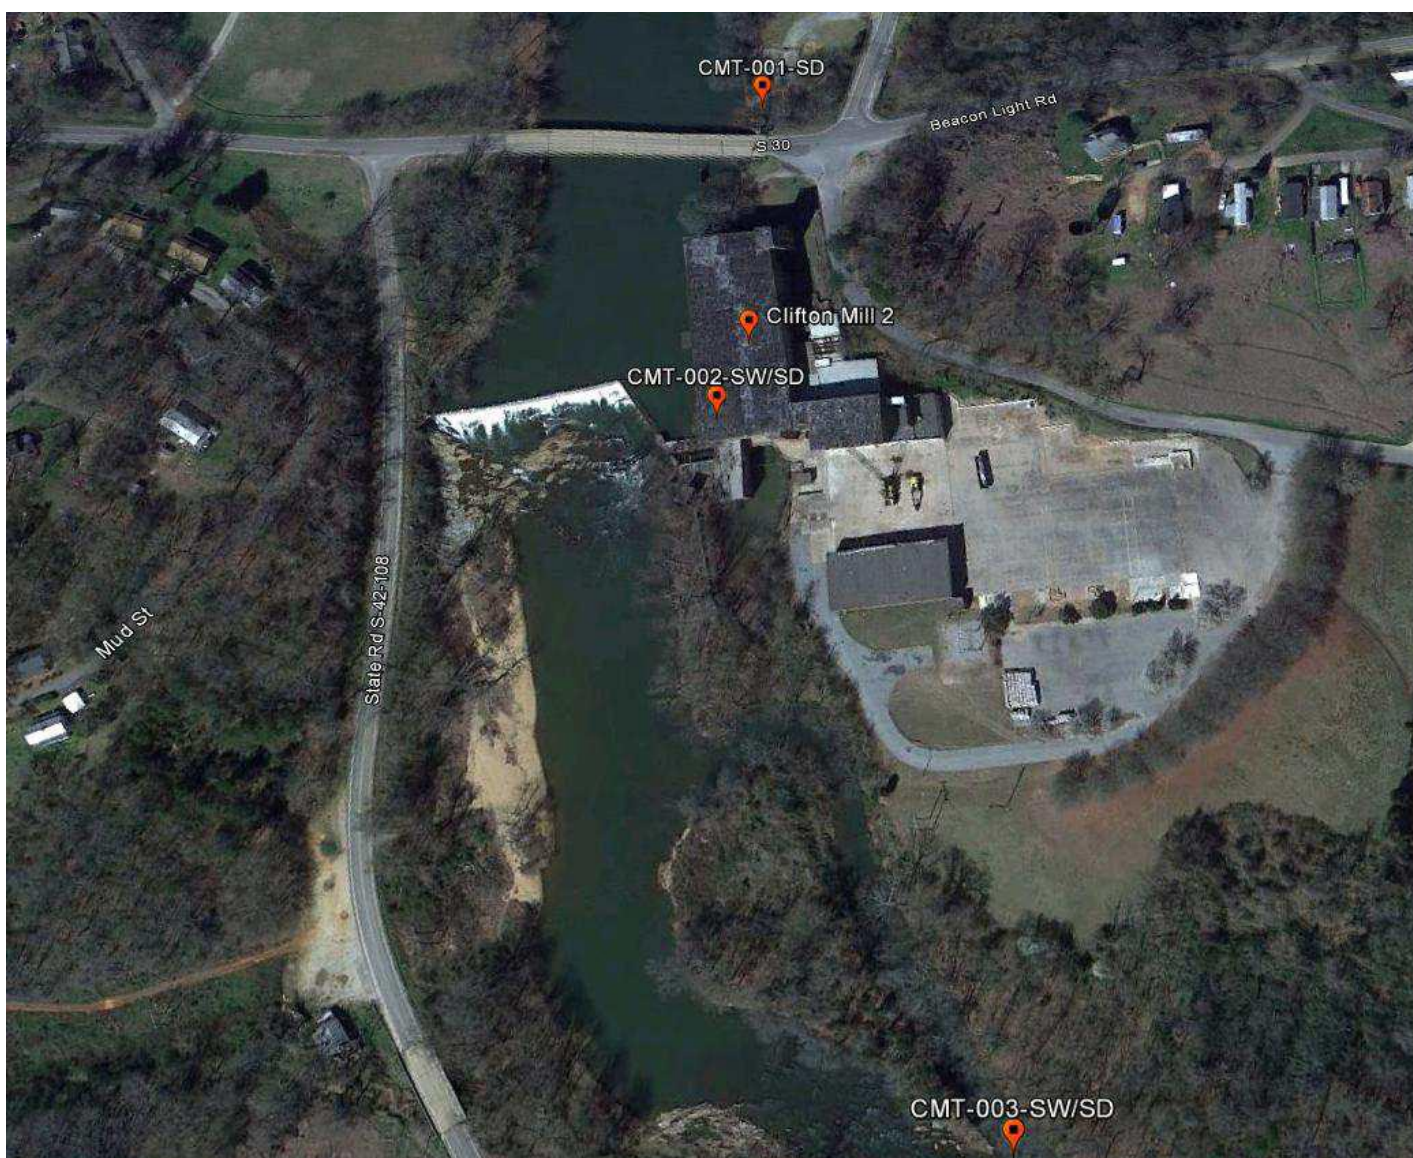
For the three samples collected within the impounded reach of the Clifton 2 Mill Dam, no chemicals exceeded the PECs and almost all chemicals were less than the TECs. No polychlorinated biphenyls (PCBs) were detected in the samples from the impounded area, and the only organochlorine pesticides detected were gamma-chlordane (0.32 µg/kg) and alpha-chlordane (1.8 µg/kg) which were less than their TECs. For heavy metals and metalloids (Table 3), only chromium (45 mg/kg) and nickel (24 mg/kg) at site CMT-002 adjacent to the mill marginally exceeded their corresponding TECs (43.4 mg/kg for chromium and 22.7 mg/kg for nickel). Similar levels of chromium and nickel were found in downstream sediments. All other metals were less than their TECs. None of the three samples collected within the Clifton 2 Mill Dam impoundment exceeded the TECs for polycyclic aromatic hydrocarbons (PAH) (Table 4). Concentrations of eight PAHs in the first sediment sample collected downstream of the mill and dam (CMT-003) exceeded the TECs.

Figure 11. Locations near the Clifton 2 Mill of sediment samples collected by SC DHEC in 2012. One additional sample (CM-005) is located in between this dam and the Clifton 1 Mill Dam (upstream) and additional samples (CMT-004, CMT-005, PM5003, PM5004 and PM5001) were collected further downstream.
